Hydrological Report on Burra Creek Catchment

This report examines the Burra Creek catchment hydrological processes. The catchment has been through numerous changes, both physically and environmentally. On-going dry conditions due to a recent severe drought in Australia has had a significant impact on the area. In addition, the natural landscape of the catchment has undergone rural urban development. The ongoing development along the catchment has generated soil degradation, resulting in acceleration of soil erosion processes. The catchment has a significant geological feature, namely a fault line running down its centre, brought about by tectonic activity during faulting, generating rock deformation through slaty cleavage outcrops due to low grade metamorphism.

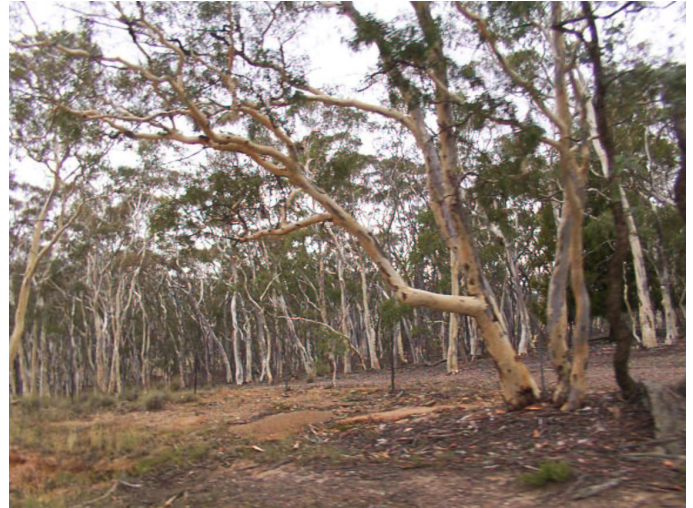
Figure 2. Native forest in the Burra Creek catchment; unvegetated understorey.

The environmental stress condition of the area can also be seen along the native vegetation areas. There is no vegetation under story (grass or small shrubs) beneath the native forest, resulting in susceptibility to soil erosion (gully, etc.) during heavy intense rainfall events. The rainfall data that were taken from the catchment show some significant rainfall events. The March to April in 1989 rainfall and discharge data have shown numerous high rainfall and discharge peaks with 220mm falling. The characteristics of the discharge peaks demonstrate a typical dry condition in the catchment during these events. The discharge response occurred a day after the rainfall starts and progressing two days later. Dry soils will readily absorb water as long as its has an undisturbed structure (not compacted).

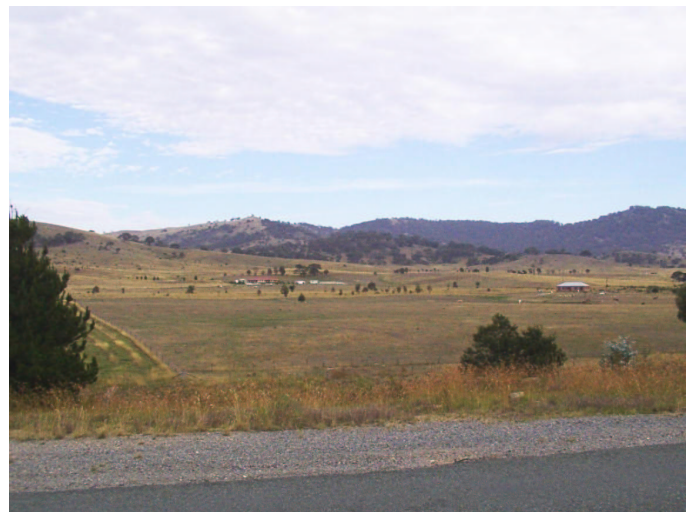
Figure 3. Small properties in Burra Catchment

The catchment of Burra Creek is composed of hills and plains. The catchment areas are a mixture of farmlands, small properties (hobby farms) and native forest areas, as shown in Figure 2 for a typical small property and Figure 3 for native forest. The headwaters of Burra Creek are in the Tinderry Mountains [Wade et al, 2002]. The creek flows are heading due north through dense native forest ranges. The landscape where Burra Creek flows as it descends is along agriculture areas. There are several tributaries of Burra Creek, and Holden's Creek is considered to be the major one [Wade et al, 2002]. Field visits into the catchment have identified very dry conditions in some creeks. Aquatic plants

Observation made during the field trip to the Burra Creek catchment region revealed a high level of agriculture activities. These agriculture areas are a mixture of small properties, including residential dwellings as shown in Figure 3. These small properties are supporting large variety of livestock such as cattle, goats, horses, sheep and lamas. The environment surrounding the catchment is under severe stress through over use, evident through the small properties which are utilised as hobby farms. Field observation shows over stocking on a number of small hobby farm properties, resulting in overgrazing, which has lead to soil degradation such as soil compaction and erosion as shown in Figure 7. There is

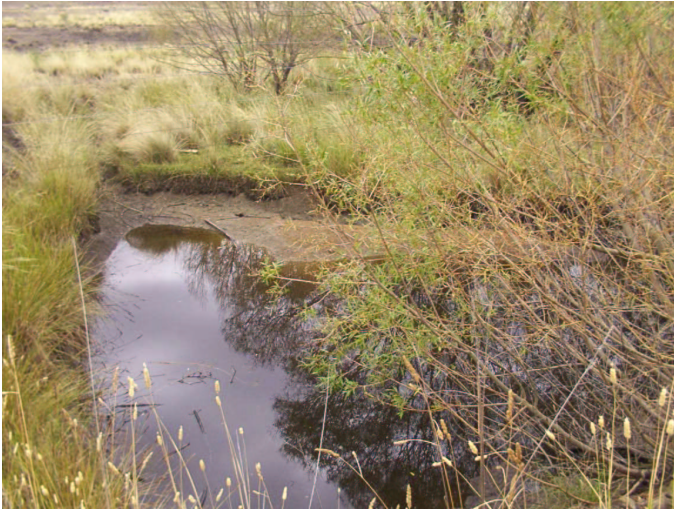
Figure 4. One of several isolated ponds in Burra Creek catchment as a result of water depletion.

are growing excessively along the creek, resulting in restriction of water flow. Brackish water conditions can be seen in some isolated ponds along the creek, as shown in Figure 4. Active farming activities such as grazing are evident along the Burra Creek catchment.

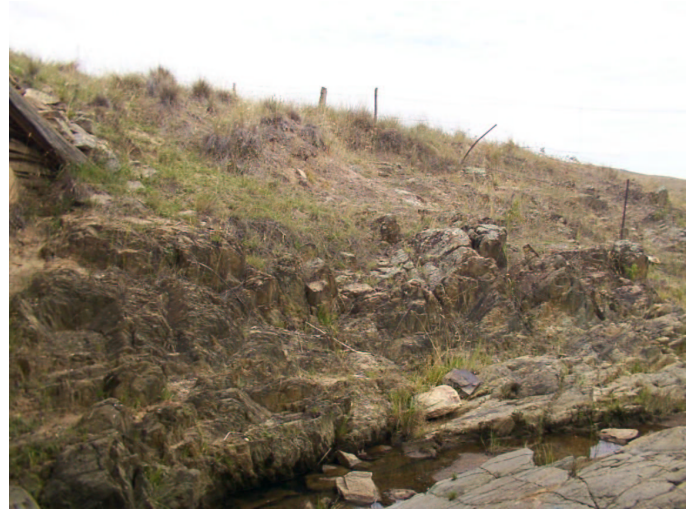
Figure 6. Highly deformed rock bedding.

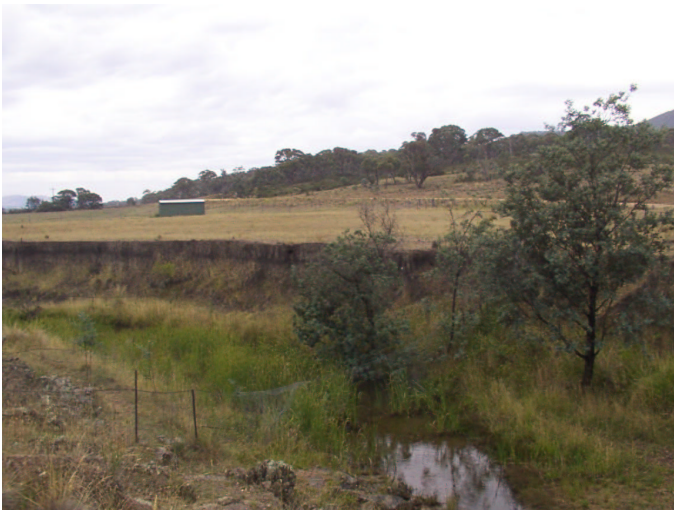
Figure 5. Distinctive sedimentary layers

Creek's bank. The sediment layers may be due to several deposition events, such as flood plains flooding, that occurred over time through environmental change in the region, see Figure 5.

obtained at the rain gauge station at the Burra Creek and the EC reading taken at this site was $560\mu\text{s}/\text{cm}$. The second EC reading result was $570\mu\text{s}/\text{cm}$ at site 2 (see Appendix for Burra Creek Catchment map). The third EC reading, taken at site 3, was $440\mu\text{s}/\text{cm}$, a bit lower in comparison to the second reading. The water content in the creek seems to have better flow at site three than the previous site (site 2). The meta-sediments in this area are of Ordovician, resulting in a high rate of erodibility. Distinctive sedimentary layers in the creek bank may be due to different deposition events over time. The dark layer and the muddy texture of the sediments is possibly due to a flooding event that must have occurred in the area, as shown in figure 5.

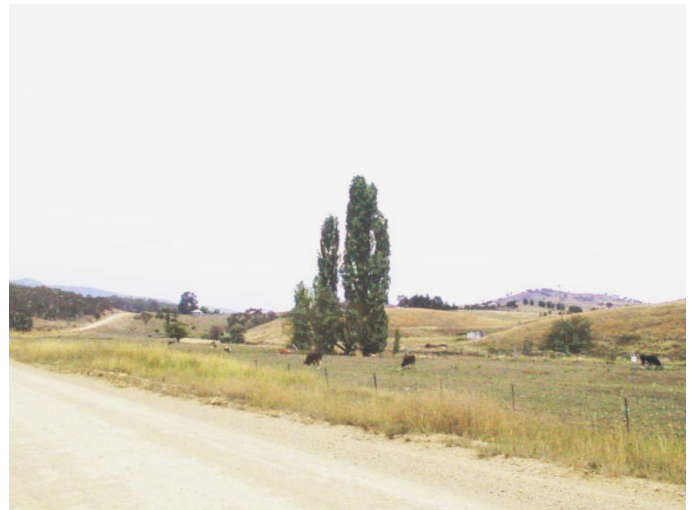
Figure 7. Small paddock with numerous cattle grazing, the vegetation in this paddock is very poor.

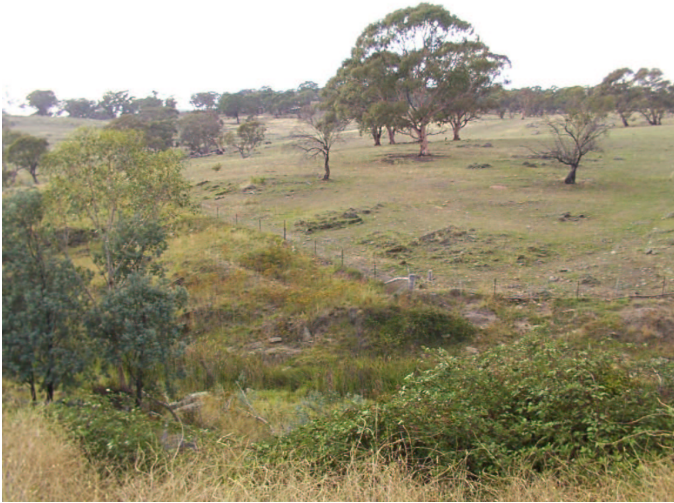
Figure 8. Very dry, low vegetation soil in Burra Creek catchment.

The removal of vegetation cover due to over grazing make it susceptible to loss of top soil, see Figure 8. Farming activities around the Burra Creek catchment region involve the use of some fertilisers. The common component of these fertilisers is nitrogen, which is used for crop growth. Some of the nitrogen is consumed for soil fertility and the rest is lost to either the atmosphere or soil surface run-off and ground water, resulting in an increase in concentration of soluble nitrogen in the waterways in the catchment [Davie, 2002]. Phosphorus is also a common component of crop fertilisers that farmers use. Phosphorus that is in bound into the soil is also carried to the waterways through soil erosion [cRcReef, 2003]. Australia has experienced severe droughts and extreme dryness, and the effect of this is evident through the condition of the grass and other vegetation in the Burra Creek catchment area.

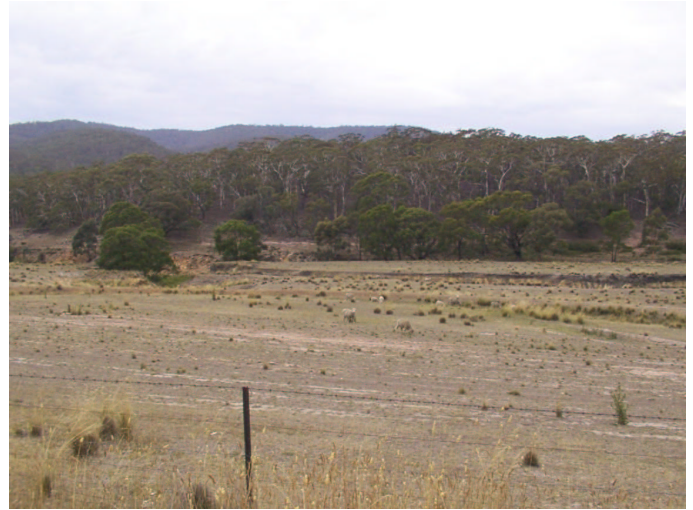
Figure 9. This picture shows a typical grazing activities in the catchment and eroded creek bank.

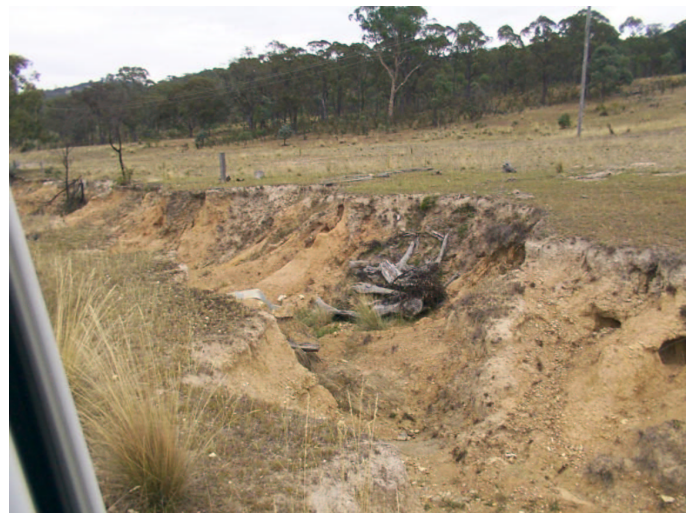
Figure 10. Active erosion processes in the catchment

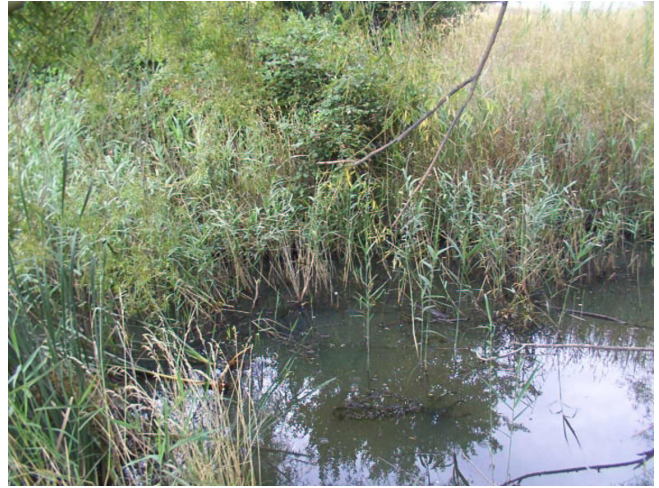
Figure 11. Excessive growth of plants in the creek

The flow along Burra Creek and its numerous tributaries has been very minimal and in some cases, due to massive aquatic plant growth, water flow is not occurring. Farmers in the catchment have been modifying the environment through planting exotic plants (e.g. Willow tree) along the riparian section of the creeks. Willow trees drop their leaves into the creek, promoting changes in the creek morphology and increased organic input into the system.

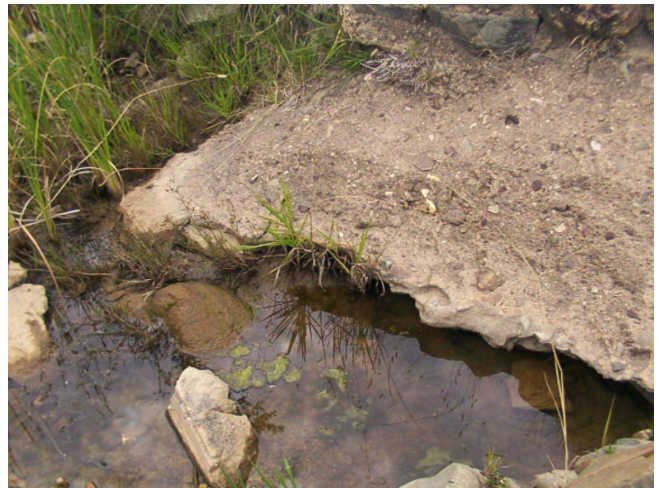
Figure 12. Algae growth in Burra Creek

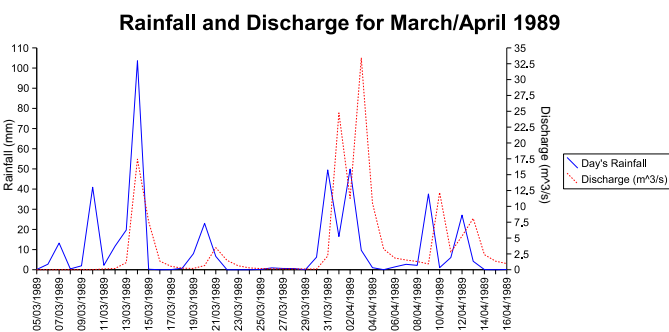
Figure 15. Rainfall and Discharge during a high rainfall period

Figure 15 shows a typical high rainfall and discharge event that occurred in Burra Creek catchment. This graph shows several high peaks of rainfall and discharge. The discharge response to these events shows a lag of a day after the rainfall

starts and proceed two days later. The discharge response rate is slower than the rainfall rate.
